## INSPECTING ON THE EDGE — UNDERSTANDING PUNCH TIP WEAR

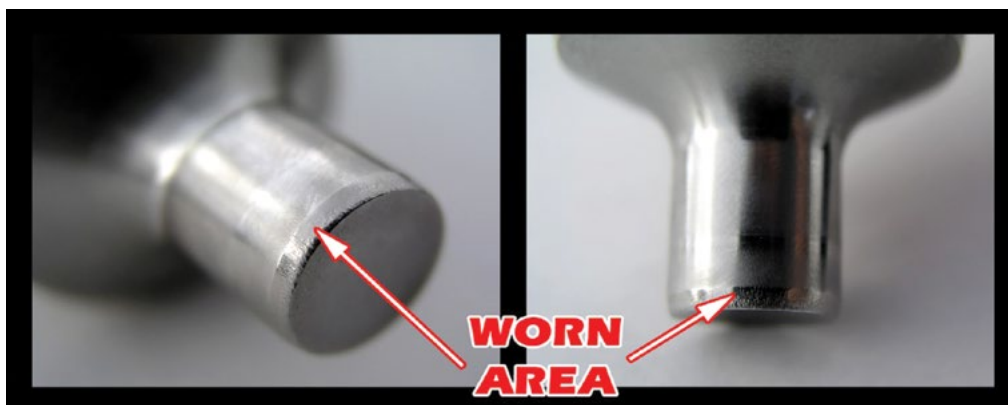
**Figure 1.** Severe outer tip edge wear.

Wear to the edges of punch tips is a commonly overlooked aspect of many tooling inspection procedures. Tip wear is typical and can be influenced by many different sources, including poor tablet and tool design, granulation characteristics, improper steel selection for the application, and improper press set-up. It is quite typical for inspection technicians to pay attention to the punch cup face. Wear to the cup face is generally not responsible for typical tablet defects such as capping, lamination, and flashing. These tablet defects are more related to punch tip land and outer edge wear.

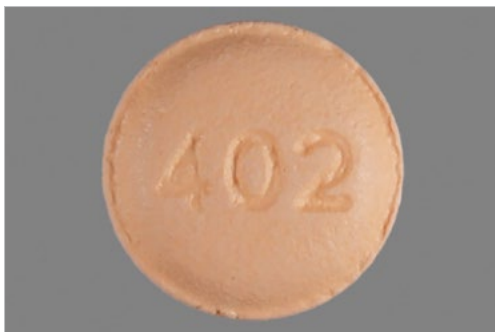
**Figure 2.** Excessive flashing on tablet

Punch tip edge wear can result from a number of conditions and may cause myriad problems including raised edges on the final compressed tablet, commonly referred to as “flashing” (Figure 2). Tablet flashing, in turn, can cause many other issues after the compression event. When tablets are subjected to de-dusting, the flashed edges may break off and cause rough, poorly defined edges. Tablets with flashing and rough edges can be difficult to film coat and can lead to loose particles adhering to the coated tablet surface. To minimize defects and downtime it is important to understand the most frequent causes of punch tip edge wear.

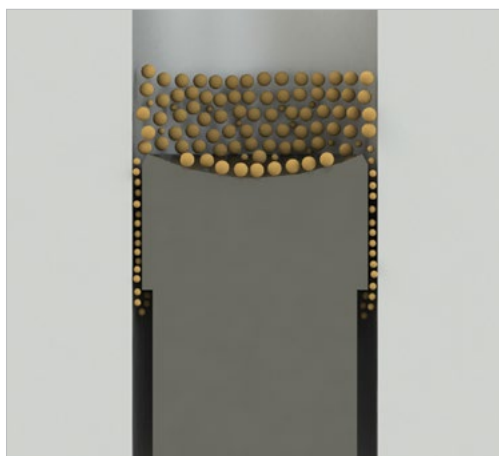
**Figure 3.** Tip wear on outer die edge and small particle sifting inside die bore.

Particle size also can affect tip wear. When small particles known as fines are present, they can sift into the gap between the punch tip and die bore (Figure 3). These small particles, combined with the cyclic motion of the punches, can cause wear on the outer edges of punch

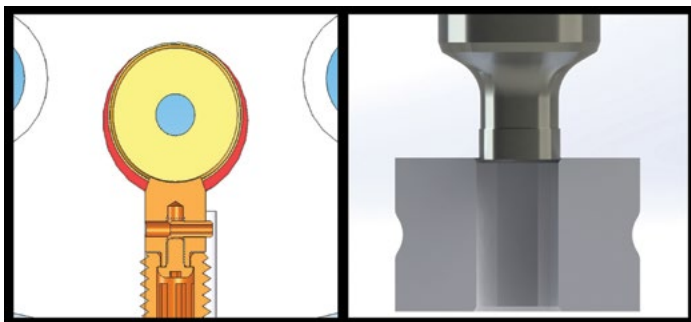
**Figure 4.** “Drop in” die pushed out of center by die lock screw causing tip edge contact with the lead-in chamfer of the die.

Dies that just “drop in” are easier to install, but consider what happens when the die lock is tightened. The die, and more importantly the die bore, will be pushed out of center to the punch tips. It is vital that the die bore be accurately centered to the punch tips. If not centered, the upper punch tip edge may strike the lead-in chamfer at the top of the die upon entry (Figure 4). Repetitive striking will quickly cause wear to the edge of the upper tip (Figure 5). With continued use this edge wear can cause flashing on the tablets as previously described. The striking can be so severe that it may curl metal of the tip inward into the cup. This condition is called J-hook (Figure 6) and may cause capping and lamination of the tablets. Also if the die bore is not well centered, the lower punch tip will have contact with the bore on one side with all the clearance on the opposite side. This increased clearance will allow product to sift into the gap, also potentially causing the excessive wear previously described. It may also create a defect to the tablet on the lower edge where the tablet band and the cup face meet (Figure 7).

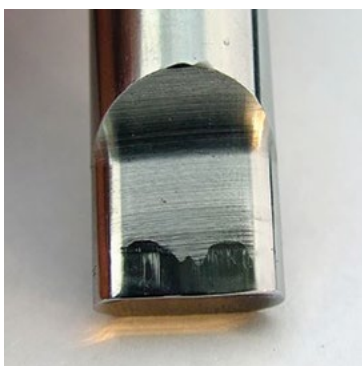
**Figure 5.** Resulting damage to punch tips

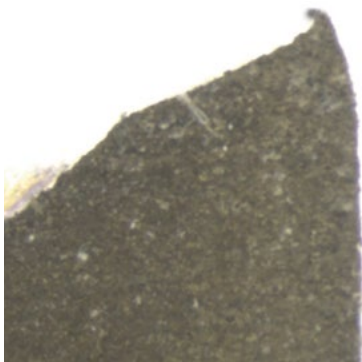
**Figure 6.** Typical J-hook

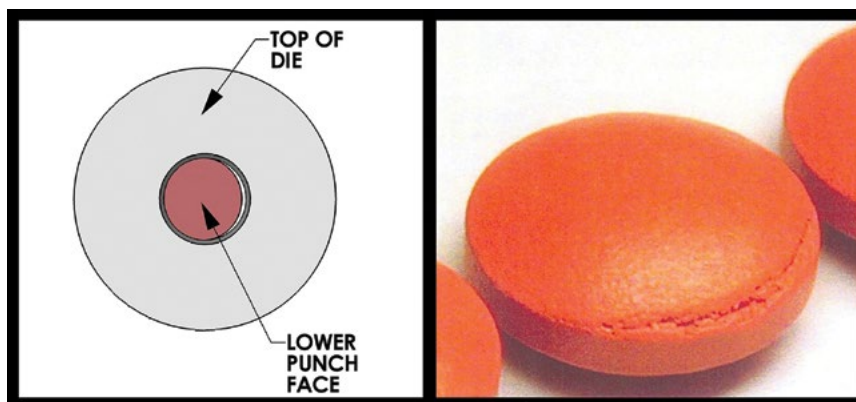
**Figure 7.** Off-center lower face and resulting tablet defect.

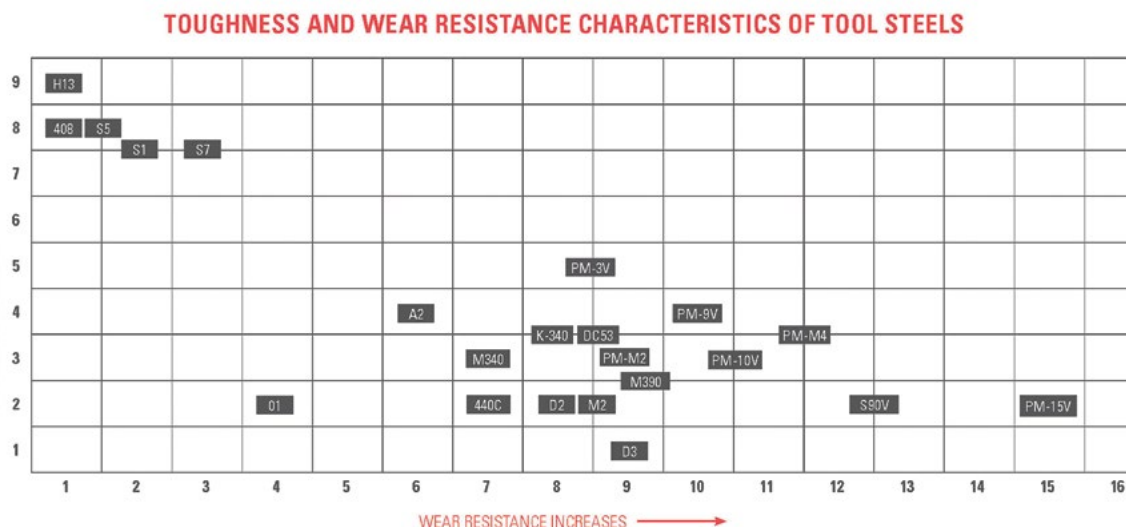
**Figure 8.**  
Toughness vs.  
wear resistance of  
various tool steels.

Selecting the proper steel type can help reduce tip wear for abrasive granulates. Reputable tool vendors offer a variety of different steel types for challenging formulations. Abrasive wear-resistant tool steel grades include AISI (DIN) D2 (1.2379), M2 (1.3343), DC-53 and K-340. For very abrasive products, punches can be produced from premium wear-resistant PM grade steels (PM=Particle Metallurgy), such as PM-3V, PM-9V, and PM-10V. As the hardness increases on premium tool steels so does the abrasive wear resistance, but it must be noted that the impact toughness decreases somewhat (Figure 8). Some steels are required to be cryogenic tempered (-184°C, -300°F) to increase wear resistance and receive full return on investment. If your vendor does not offer this tempering process, the steel type or your tooling vendor should be reconsidered. It is the combination of each steel's unique chemistry and the related heat treatment process that allows the different steel types to attain their advantageous unique mechanical properties. This makes them ideal for the wear resistance needed for abrasive formulations yet still allows them to support the compression forces needed for the high-stress, high-cycle loading conditions of tablet compression.

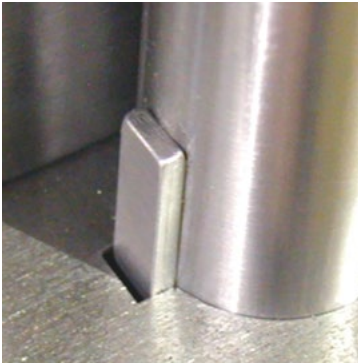
**Figure 9.1.** Punch key not pre-loaded.

Press set-up can be critical in reducing and preventing accelerated tip wear. Pre-loading is the process of twisting the keyed upper punch in the direction of turret rotation while using the upper punch to set the angular alignment of the die bore shape. Pre-loading simulates the rotational forces that the upper punch experiences when the press is in operation. When using shaped/keyed tooling, pre-loading is often not practiced. All presses have clearance in the key slot of the turret, which may increase further as the turret wears. If the punches are not pre-loaded when setting the die alignment, the upper punch will shift angularly as the turret rotates (Figure 9.1, 9.2, 9.3). This creates angular misalignment between punch tip and die bore resulting in accelerated wear to the outer edge of the upper punch tip due to contact with the die bore as it enters. Following simple set-up procedures such as pre-loading, combined with periodic turret inspections, can greatly reduce unnecessary tip wear.

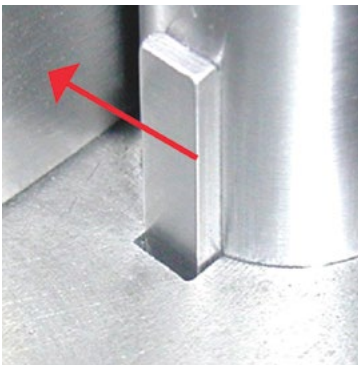
**Figure 9.2.** Punch key flush with left side of slot after pre-load applied (Note: these photos depict CW rotating turret).

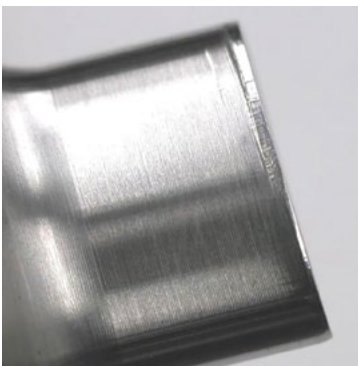
**Figure 9.3.** Tip damage from lack of pre-load.

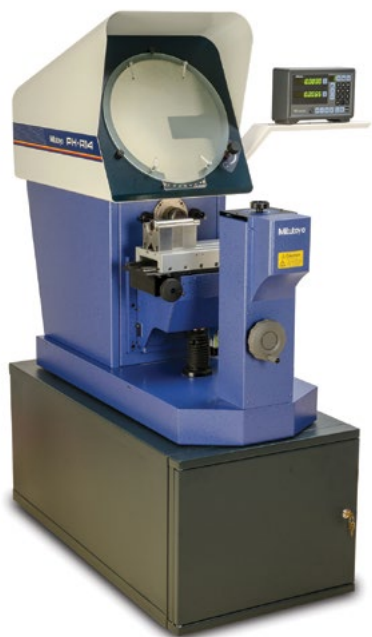
**Figure 10.1.** Horizontal optical comparator.

Visual inspection for tip edge wear is quite challenging, especially without magnification. The quickest and most efficient method is to use a horizontal optical comparator (Figure 10.1, Figure 10.2). An optical comparator (often called a comparator) is an apparatus that applies the principles of optics to the inspection of manufactured parts. In a comparator, the magnified silhouette of a punch tip is projected upon a screen, usually at 10x, but can also be at 20x or even greater magnification. The wear of the part can be easily inspected and even measured against prescribed limits. Unfortunately, a comparator is not used often in the industry but is a valuable piece of equipment. For a reasonable investment, it is the only efficient method to check punch tip wear.

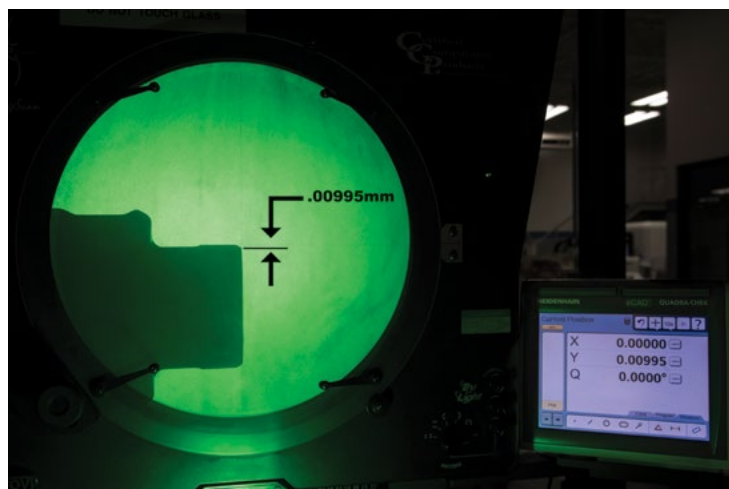
**Figure 10.2.** Inspection of punch tip with worn edge on optical comparator
